**THE STREAMBANK EROSION CONTROL
EVALUATION AND DEMONSTRATION ACT OF 1974
SECTION 32, PUBLIC LAW 93-251**

Appendix H - Evaluation of Existing Projects Volume 2 of 2

APPENDIX H EVALUATION OF EXISTING PROJECTS VOLUME 2 OF 2

Consisting of
A BRIEF SUMMARY REPORT AND INDIVIDUAL EVALUATION
REPORTS ON FIFTY EXISTING STREAMBANK EROSION CONTROL
PROJECTS CONSTRUCTED PRIOR TO OR SEPARATE FROM THE
SECTION 32 PROGRAM

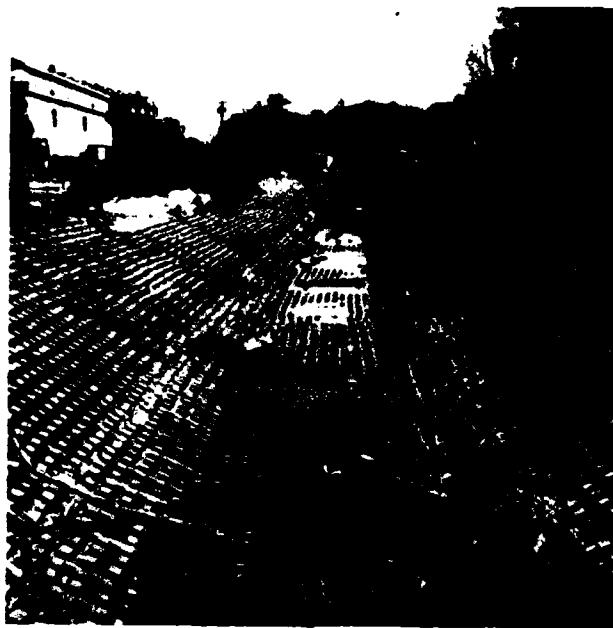
Looking downstream at Monoslab revetment,
Hayward Creek at Quincy, Massachusetts
(photograph furnished by New England
Division, July 1978)

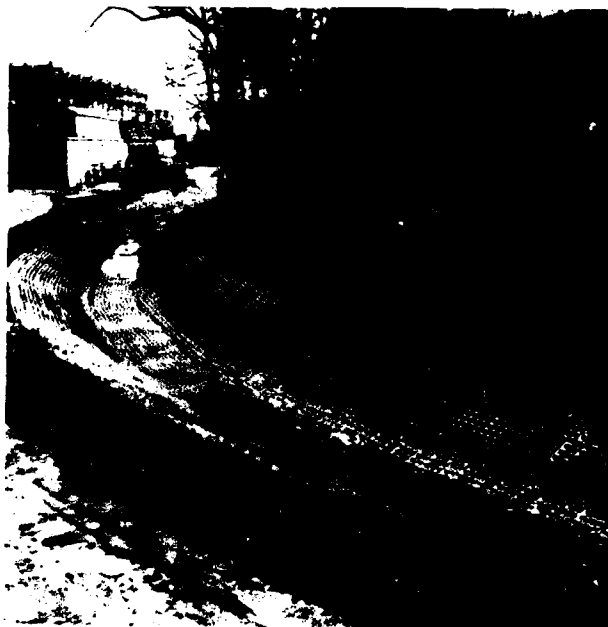
Upstream view of Monoslab revetment, showing
trapezoidal channel cross section, Hayward
Creek at Quincy, Massachusetts (25 July 1978)

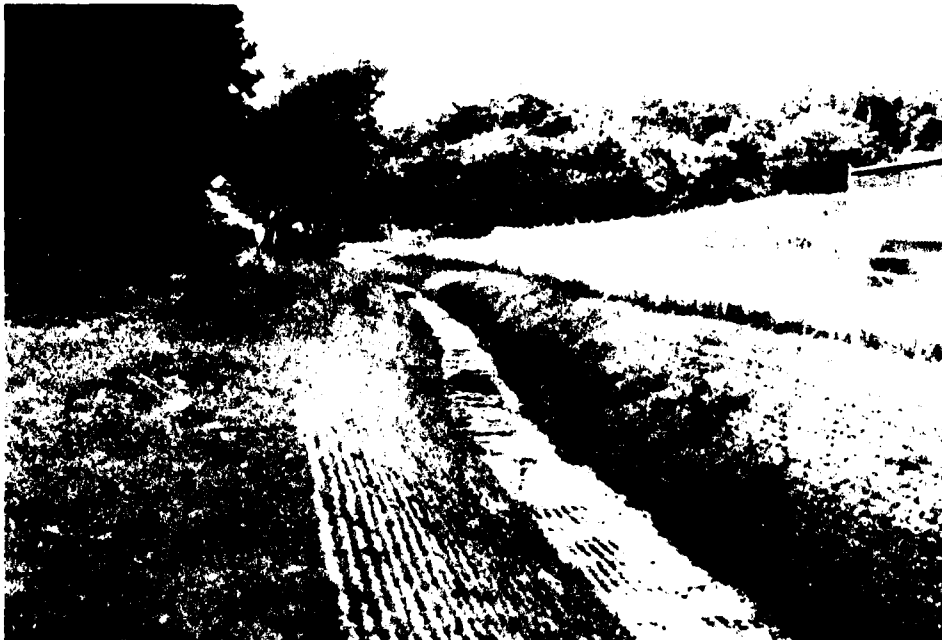
Looking upstream from Sta 1+25

MONOSLAB REVETMENT TWO YEARS AFTER CONSTRUCTION
HAYWARD CREEK AT QUINCY, MASSACHUSETTS
(SEPTEMBER 1980)

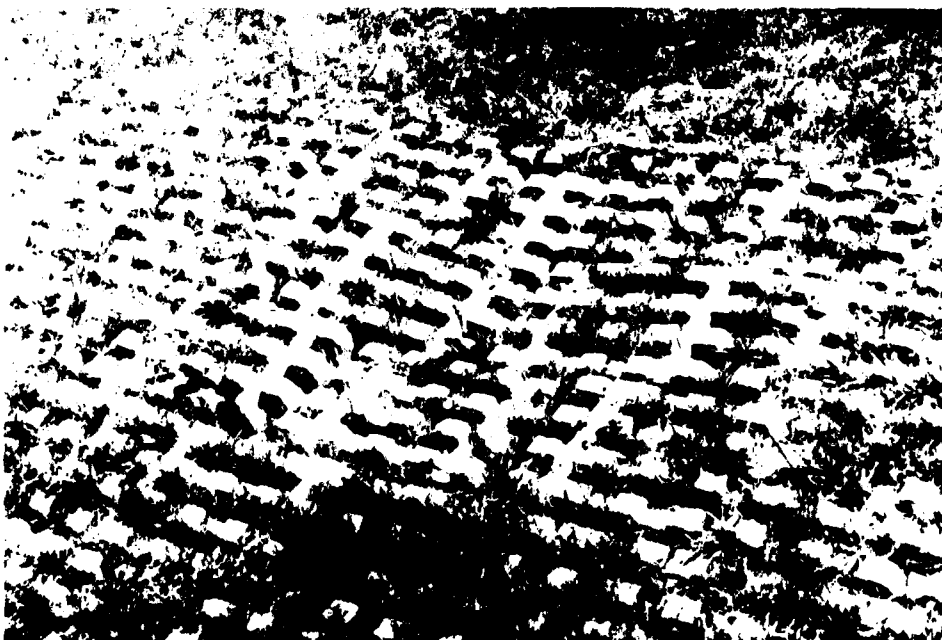
Settlement of upper right slope at Sta 3+50

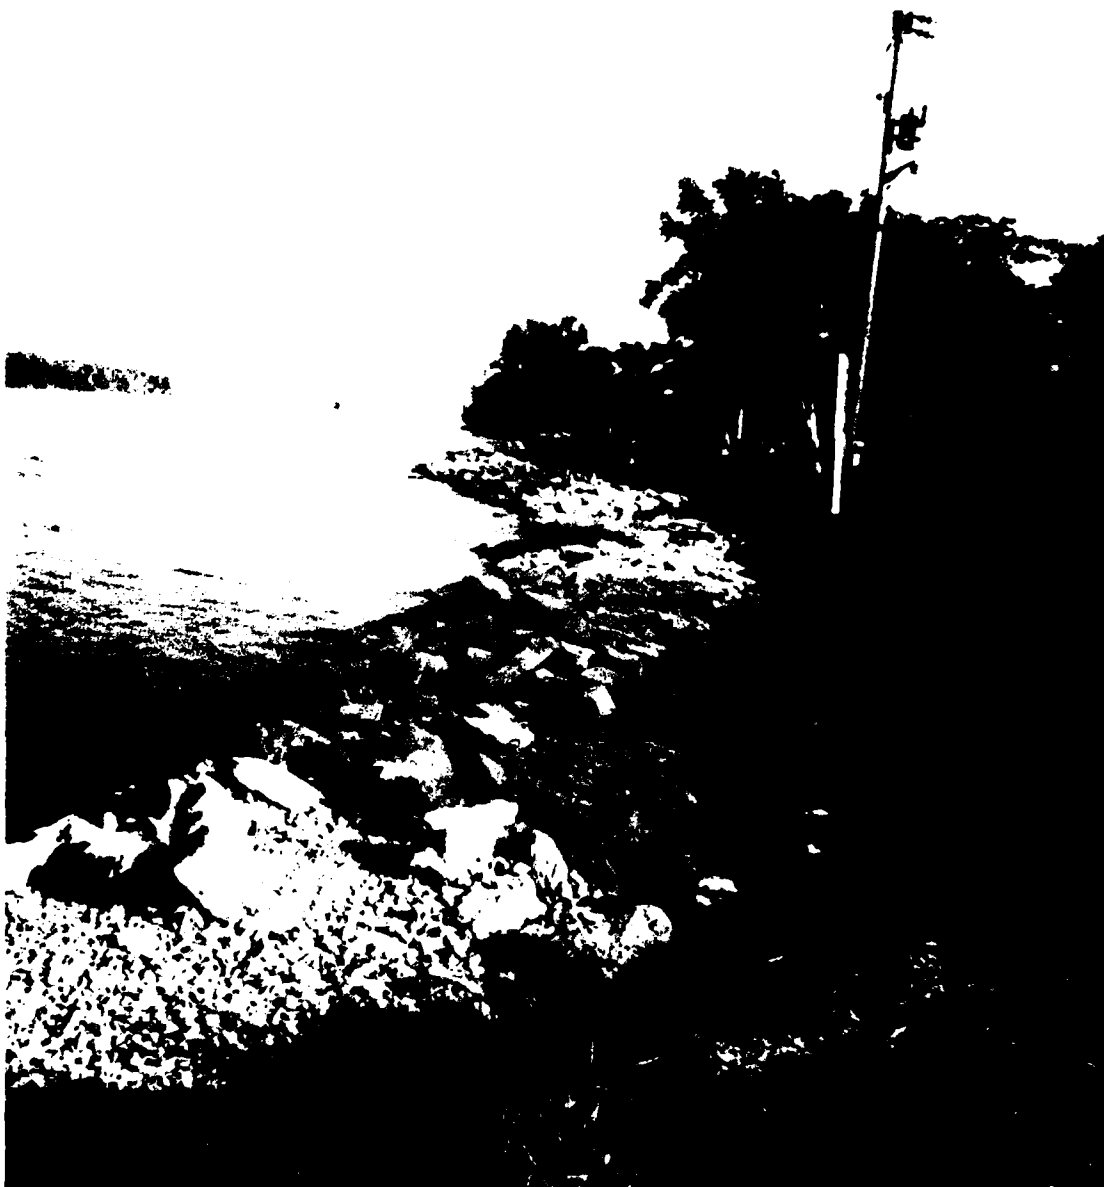
ITEM 28-2

Any settling of the revetment should be complete now. Slope stability is not a problem, since the riprap slope is gentle. Some of the finer gravel included with the riprap may occasionally wash away, but, overall, erosion of the revetment is insignificant.

St. Marys River Project, 4 years after construction, 27 June 1978

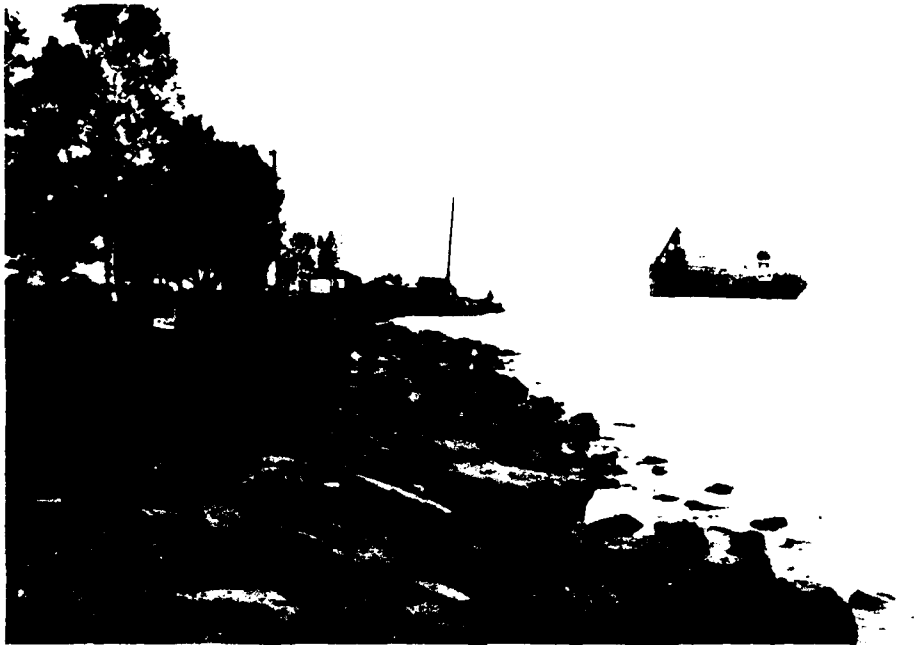
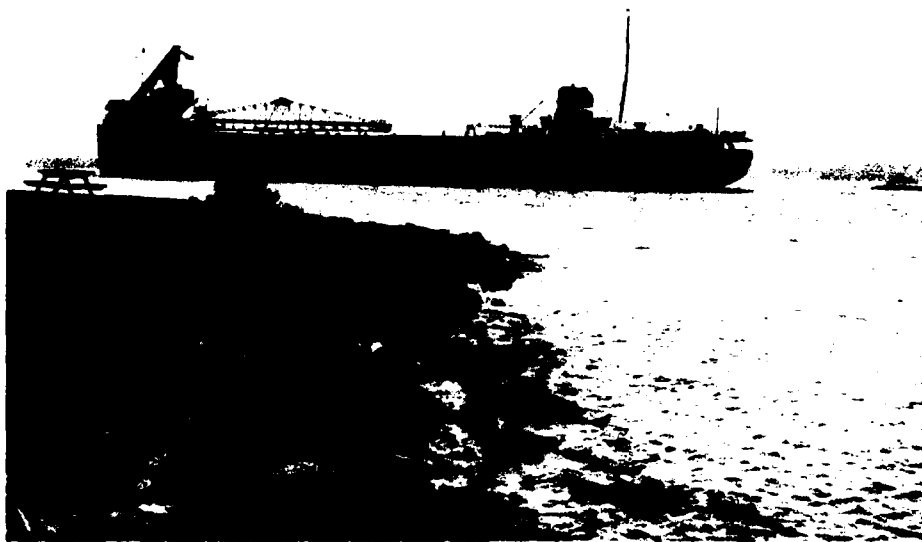
ITEM 28-4

Examples of typical wave-surge conditions on
the St. Marys River - 1980

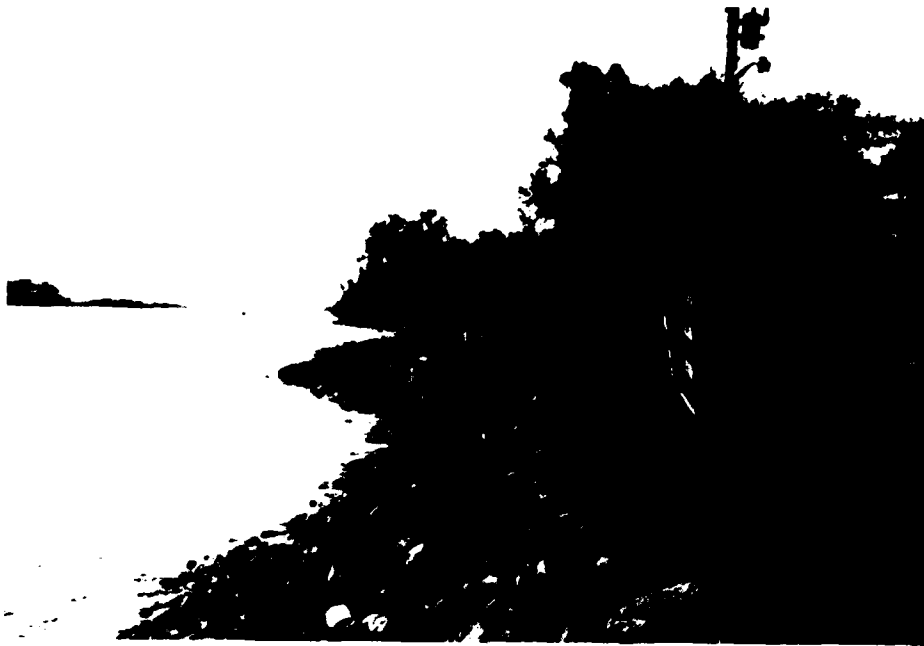
Looking downstream (south) - 1978

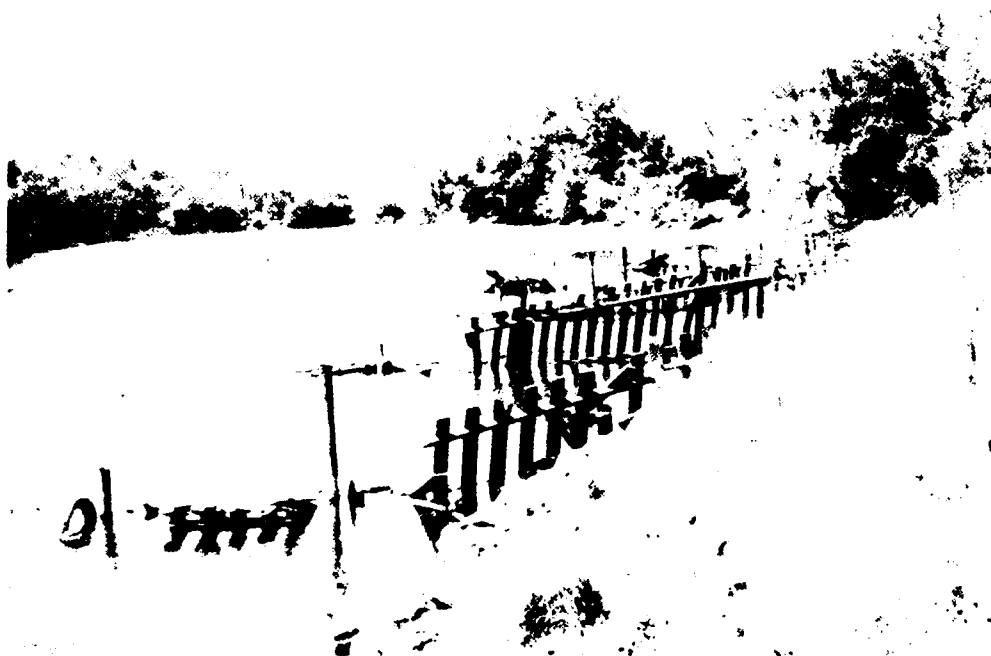
ITEM 31-3

Sept 1976 - Looking downstream at timber jetties after repairs

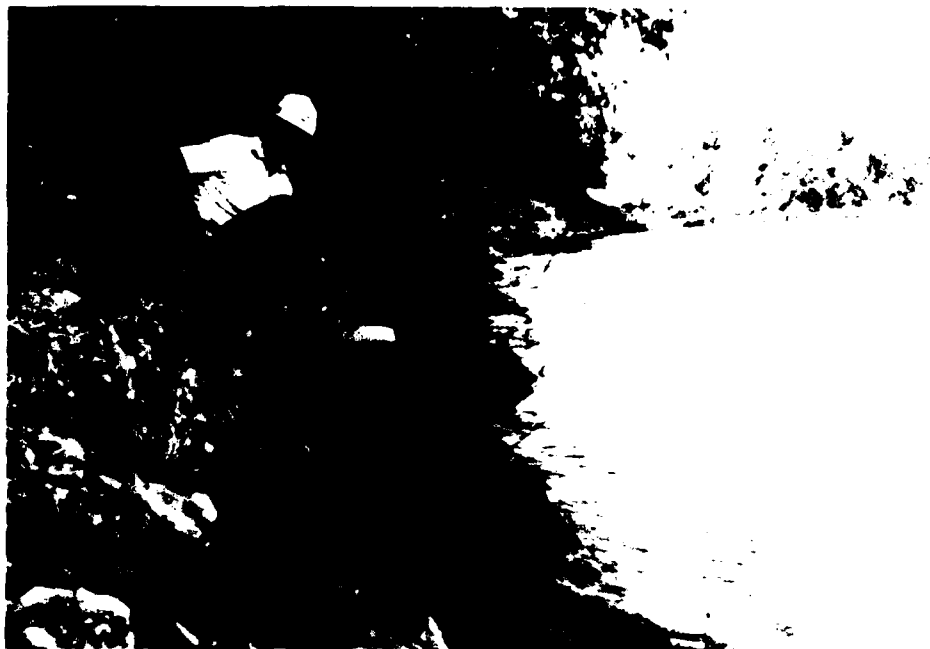
Photo 7

Taken 27 July 1979. Same area as previous photo.

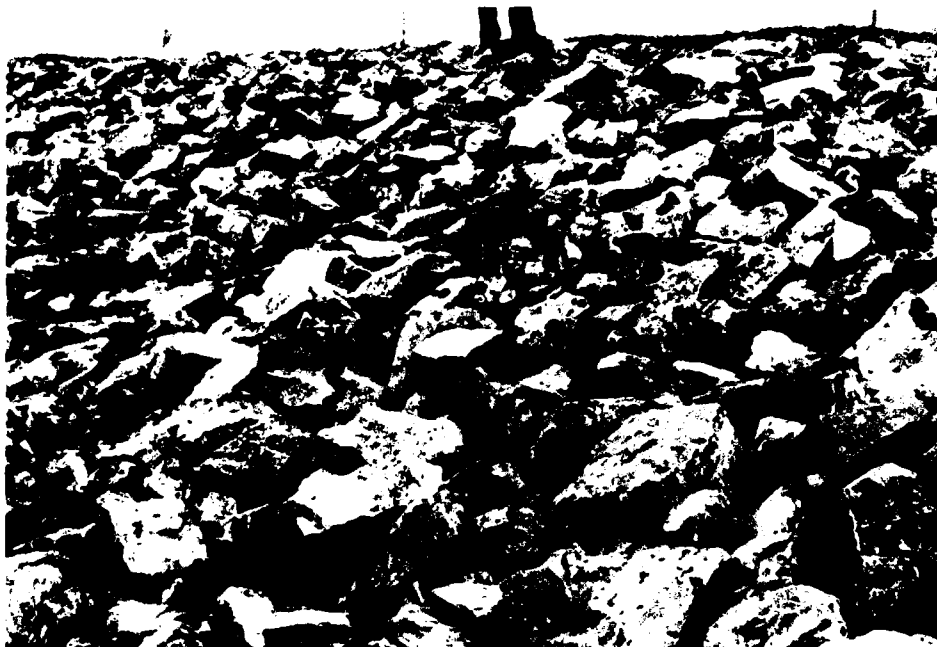
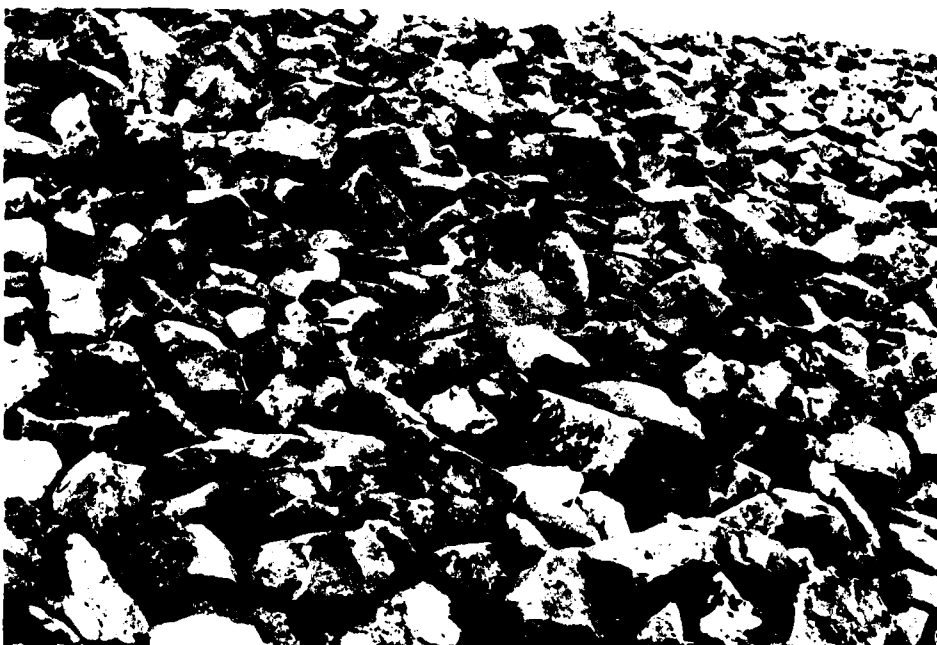
Photos 1 and 2

Right bank - typical gradation for graded riprap.
Shows uniformity and good size distribution.

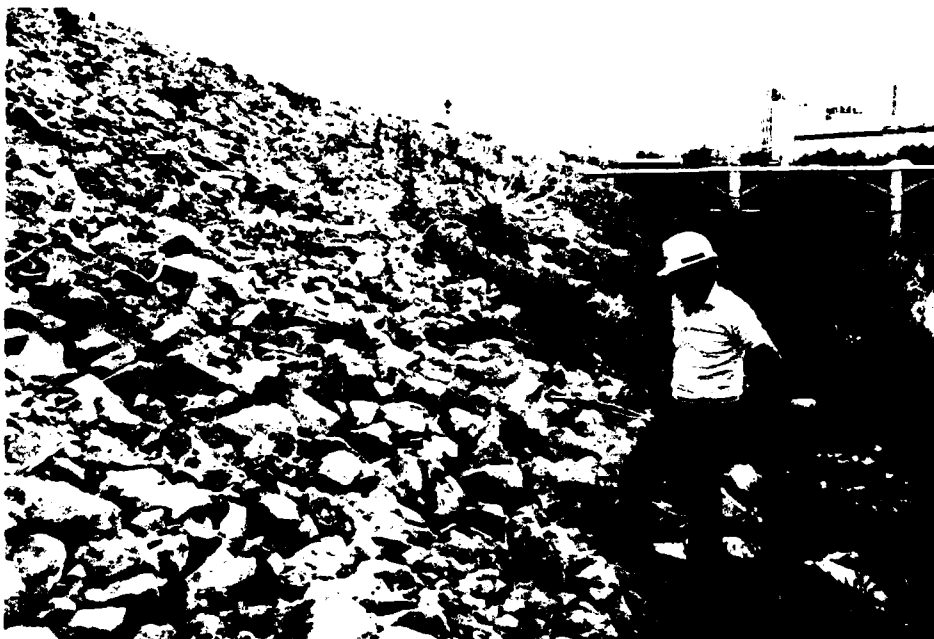
Photo 5
Left bank. Indicates amount of vegetation on bank.

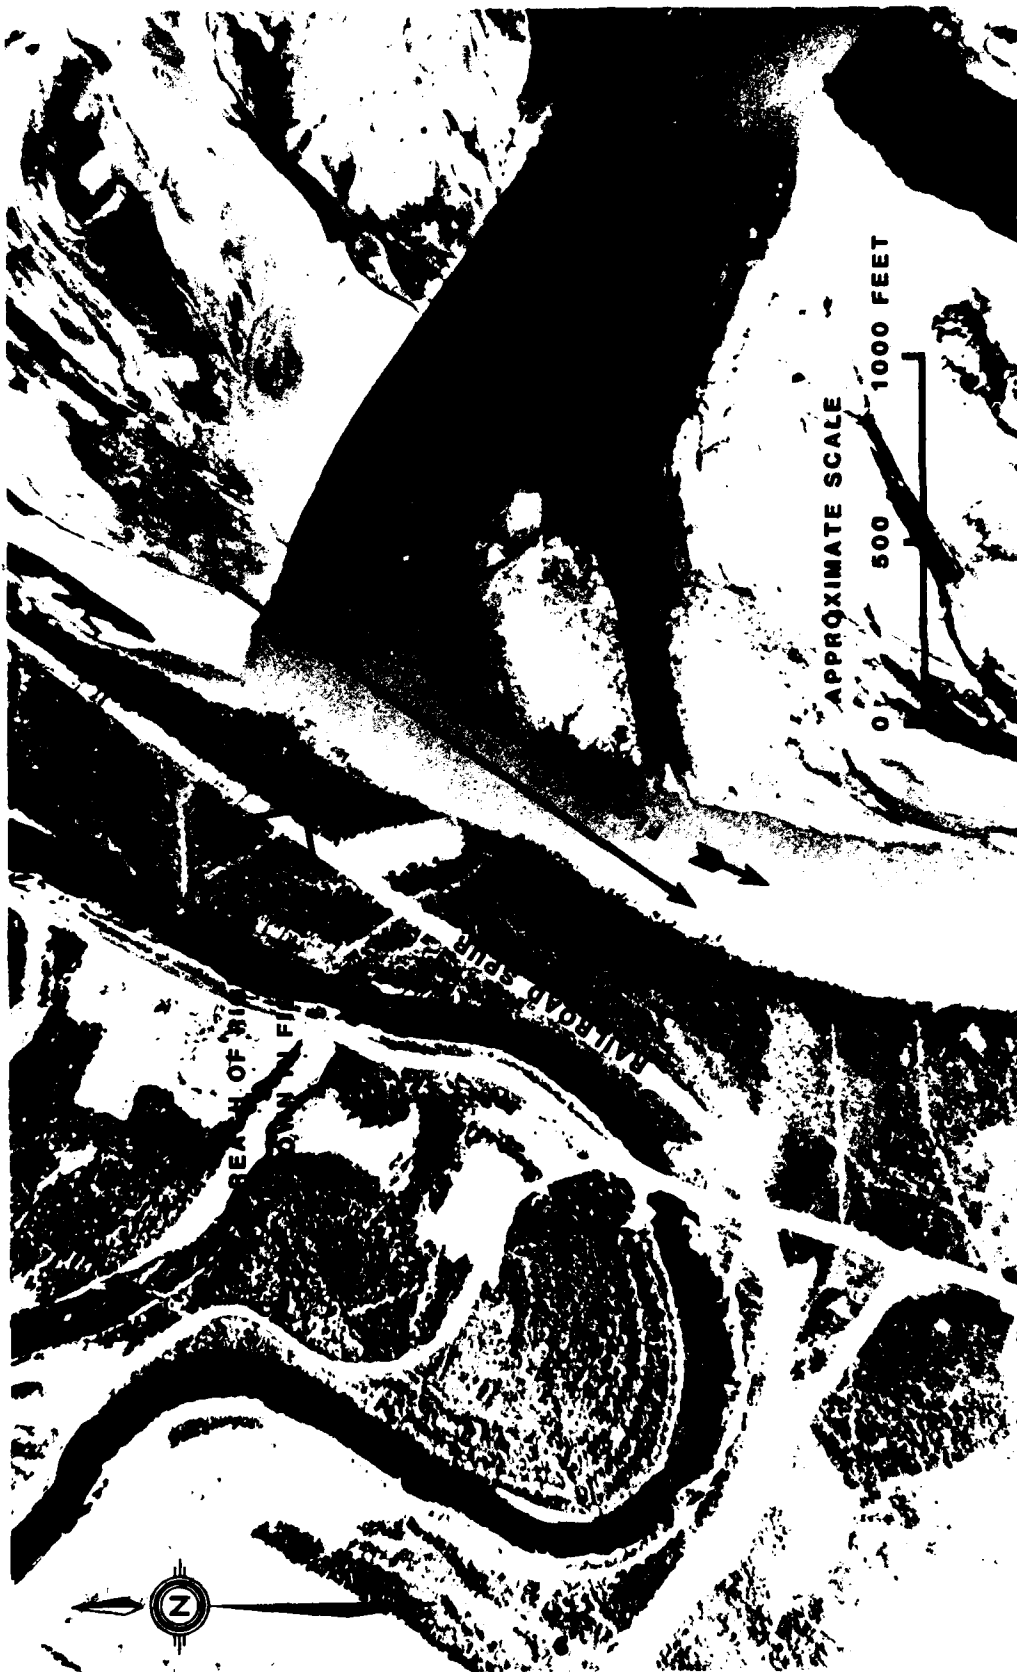
Photo 1 Location of ice revetment site on the Tanana River near Fairbanks, Alaska,
4 June 1978, river discharge is 21,600 cfs.

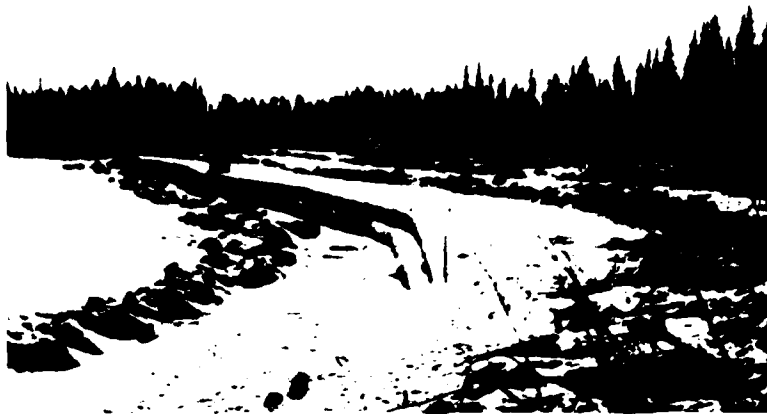
Photo 2 31 March 1979, river discharge is 4,600 cfs,
ice building for revetment completed, forms removed.

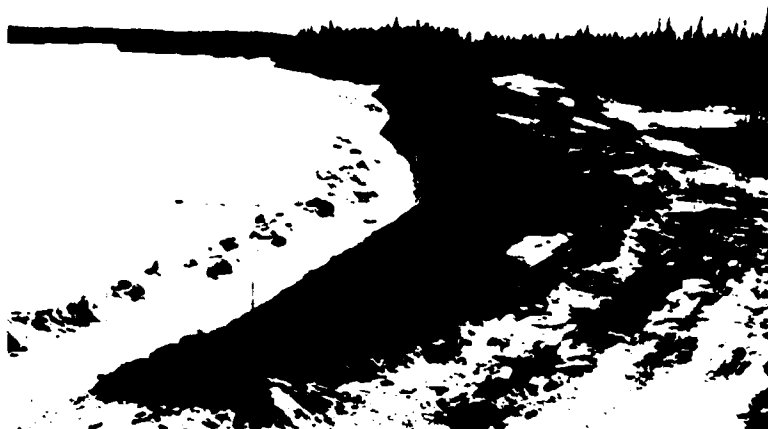
Photo 3 13 April 1979, river discharge is 5,200 cfs,
sawdust spread on top of ice revetment.

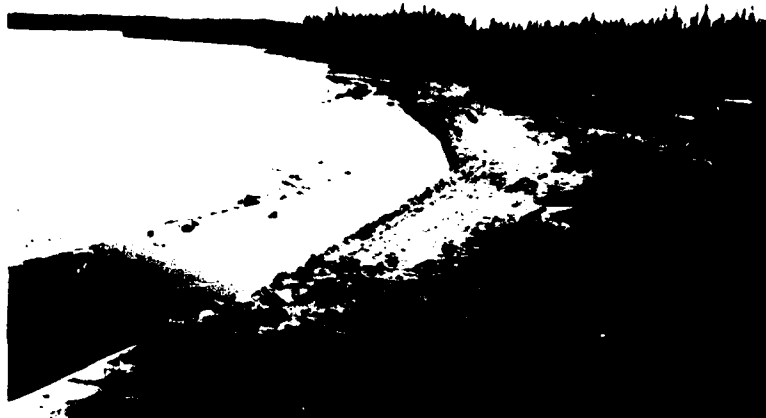
Photo 4 28 April 1979, river discharge is 18,000 cfs, more sawdust spread
onto riverbank, depressed ice sheet shows overflow in front of revetment.

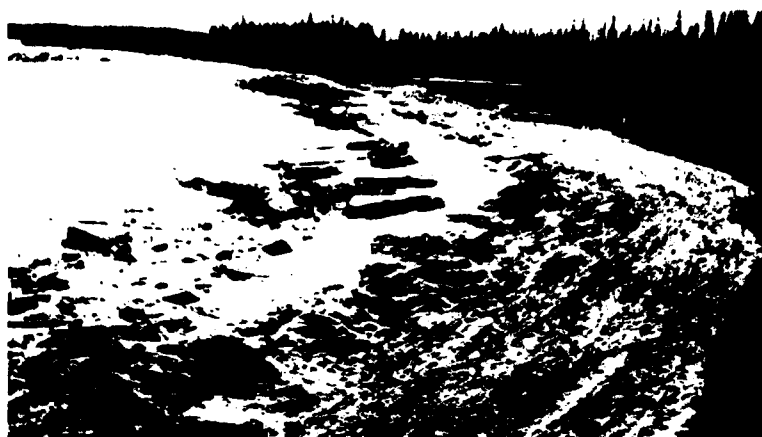
Photo 5 1 May 1979, river discharge is 58,000 cfs, during breakup ice sheet broke up on top of ice revetment.

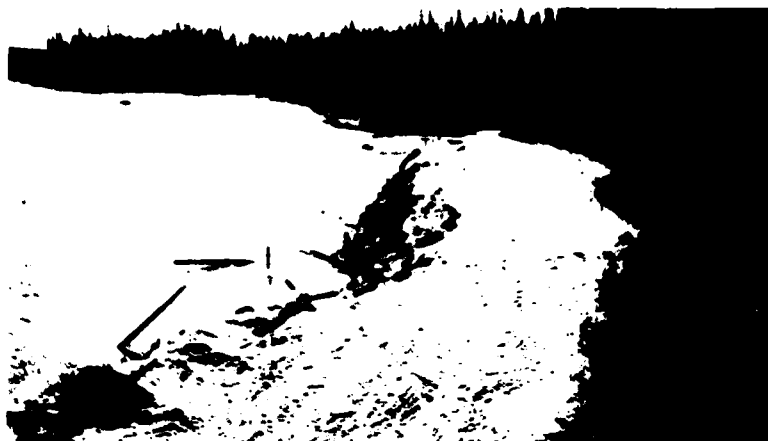
Photo 9 12 May 1979, river discharge is 27,400 cfs, ice revetment completely melted, riverbank erosion under way on upstream end.

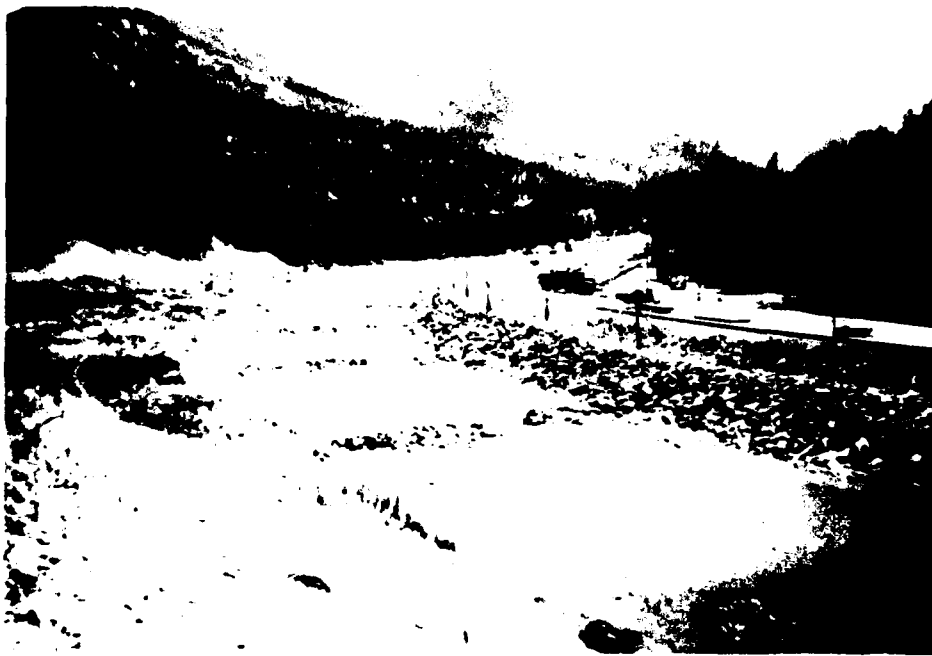
a. Condition of groins on 13 Aug 70, three years after placement.

Figure 6. Channel change 17 viewed upstream from bridge
ITEM 35-7

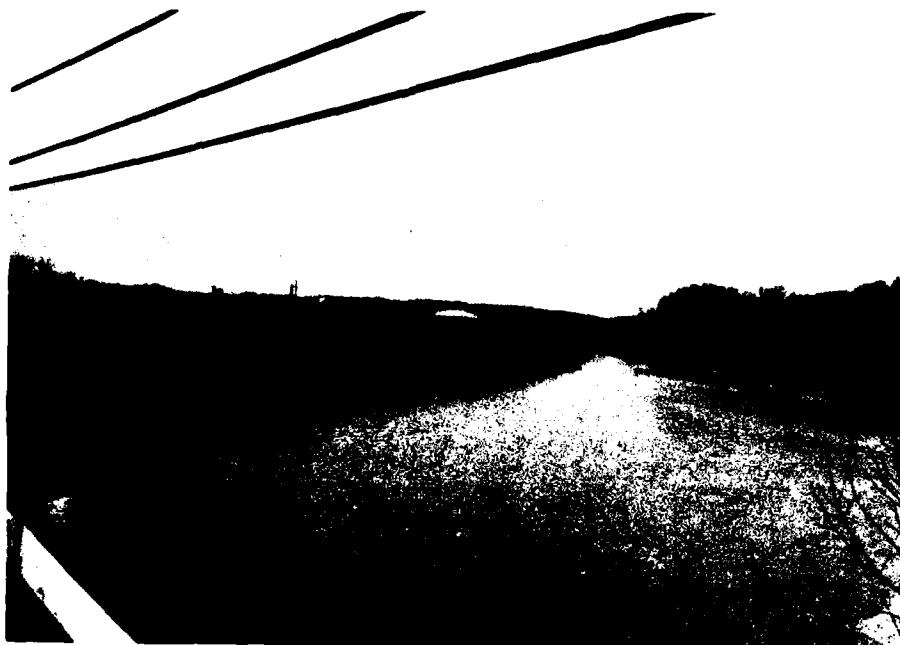
Looking downstream from Whites Mill Dam. (Dredged material on left.) April 1980.

Hocking River at Athens, Ohio.
Two Views After Dredging. (1980)

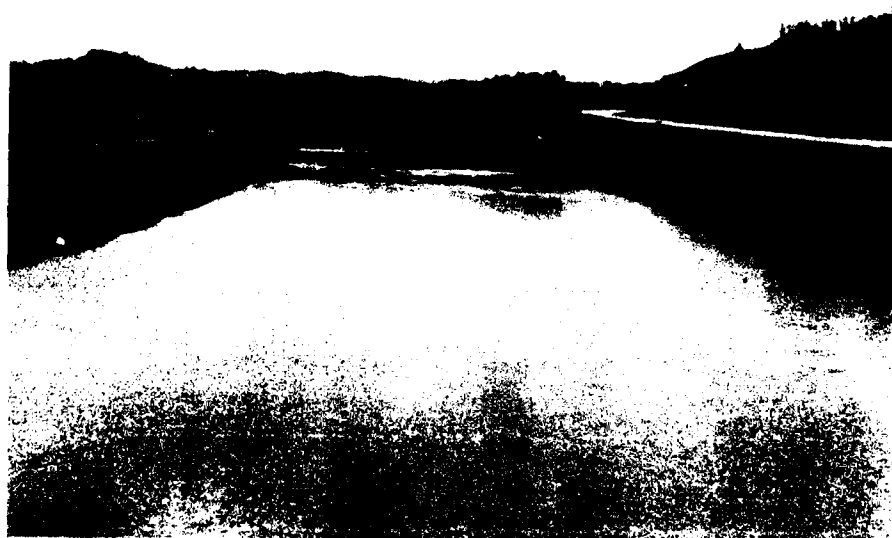
Looking downstream from U.S. Rt. 50 Bridge (Richland Ave).

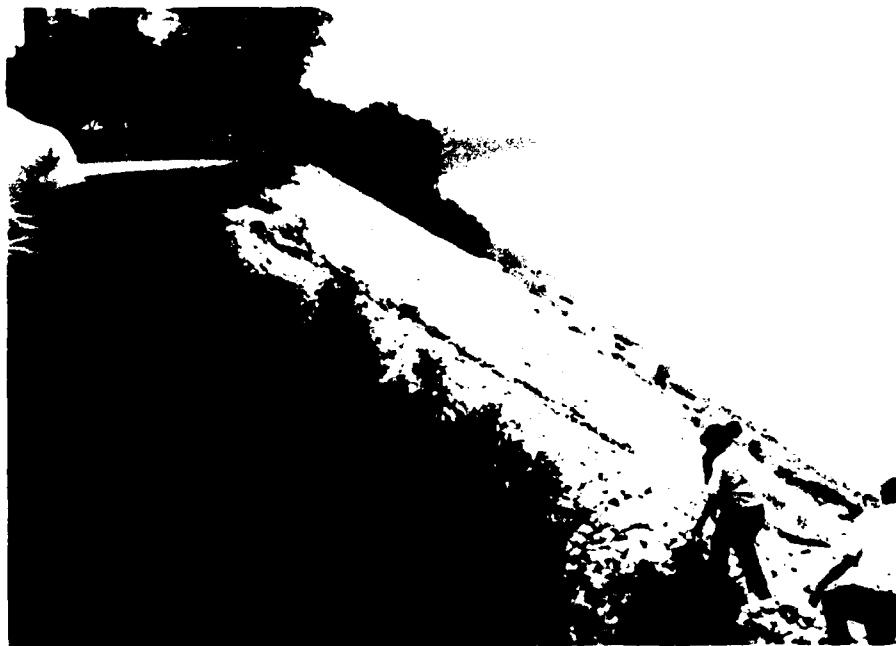
Ohio River (left bank) at Cloverport, Ky. Vegetation had become well established along the top of the revetment at the time of the WES inspection visit (19 June 1978). The pool elevation is 348 ft. U. S. Highway 60 is to the left; the view is downstream

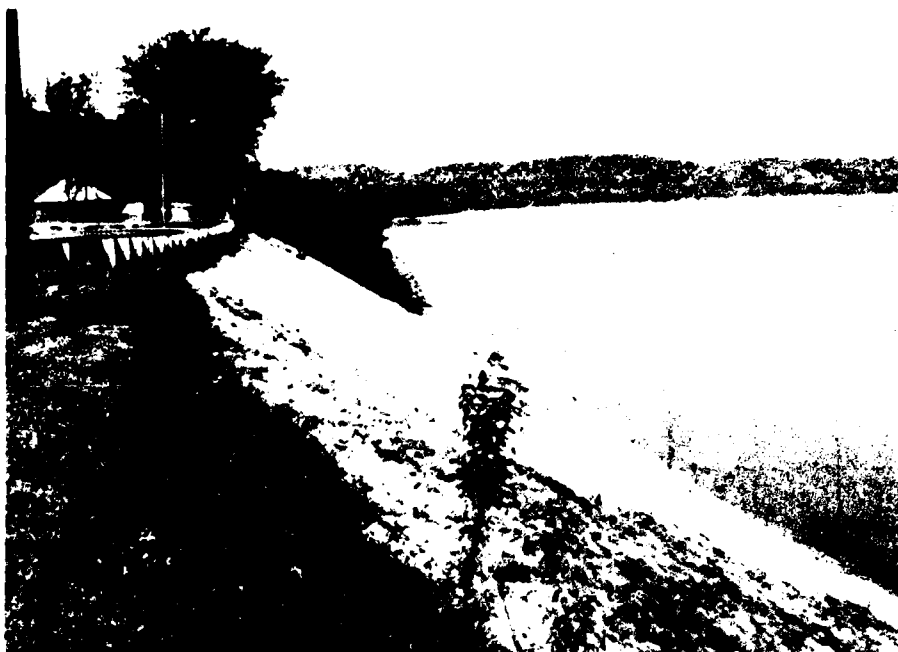
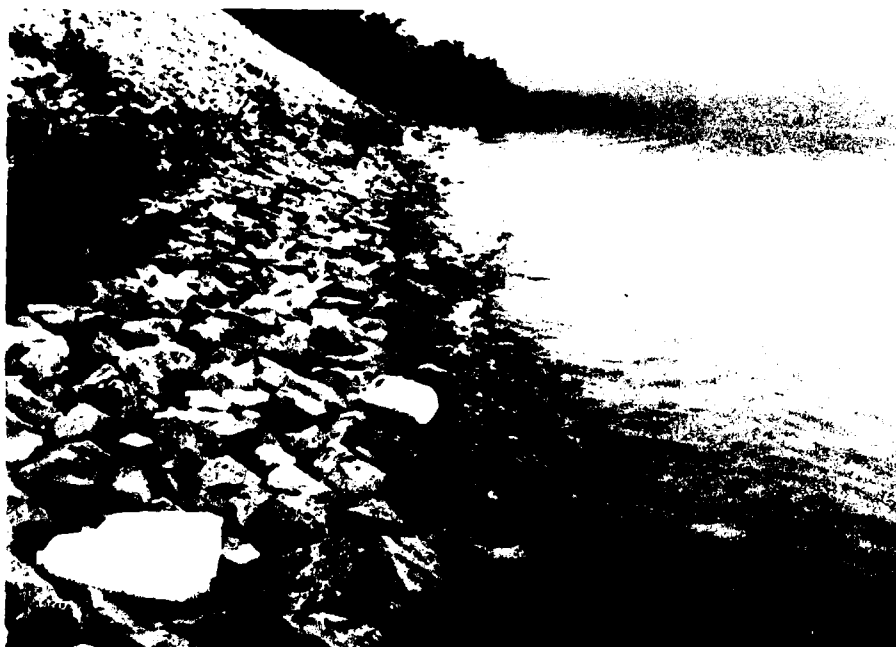
Ohio River (left bank) at Cloverport, Ky. Downstream view shows toe of
revetment under wave attack due to passing barge traffic (19 Jun 1978)

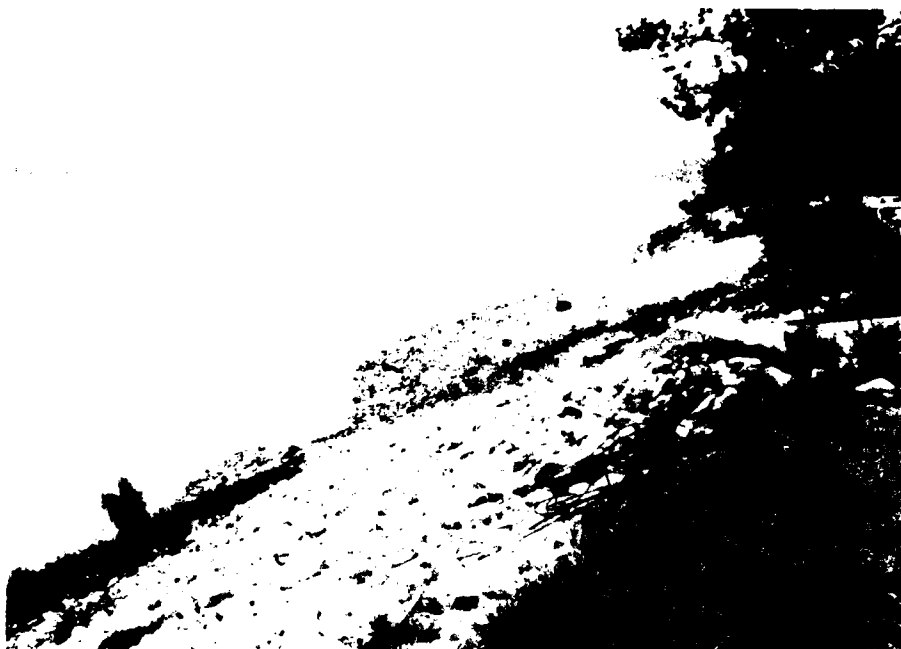
ITEM 38-3

a. View from top of revetment.

Ohio River (right bank) at Newburgh, Inc. Two downstream views of the riprap revetment (19 Jun 1978). The pool elevation is 343 ft.

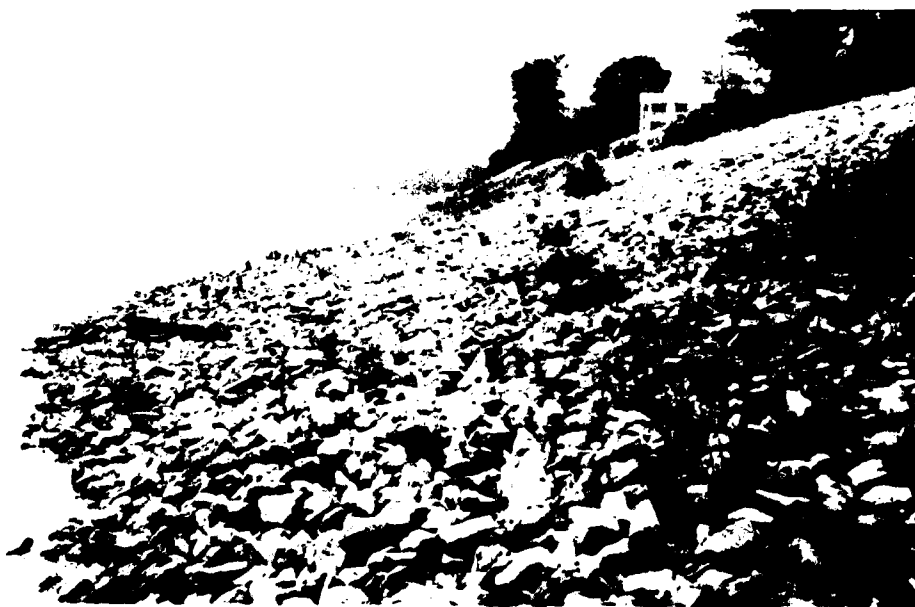
b. View from toe of revetment.

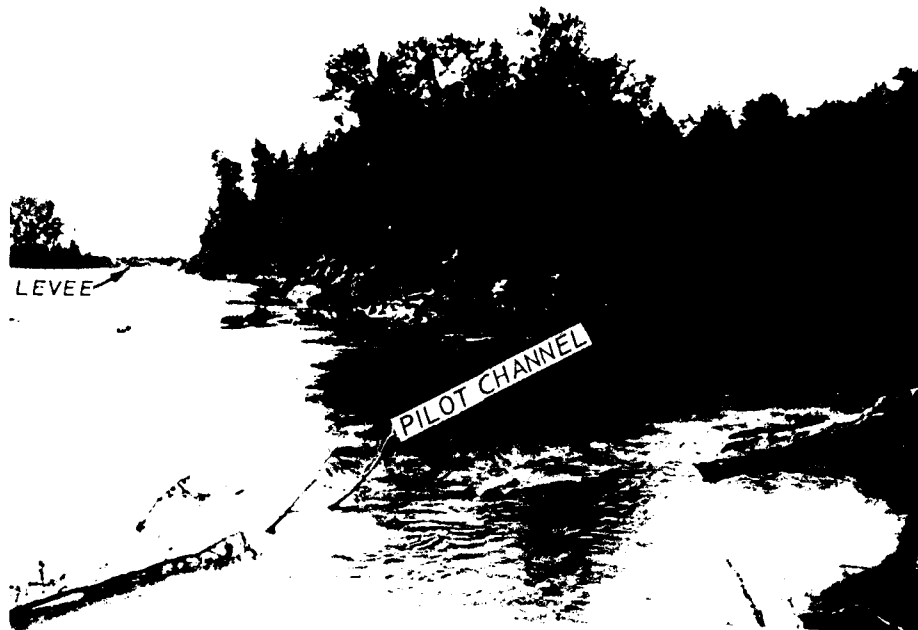
ITEM 39-4

Pilot Channel 1, White River, Levee Unit 8 at Edwardsport, Inc. The upstream end of the pilot channel is to the right; the natural streambed is to the left. Note the levee in the background and deposition in the natural channel. The estimated total discharge is approximately 5,600 cfs, with 95 percent flowing through the pilot channel (20 June 1978).
View toward downstream direction

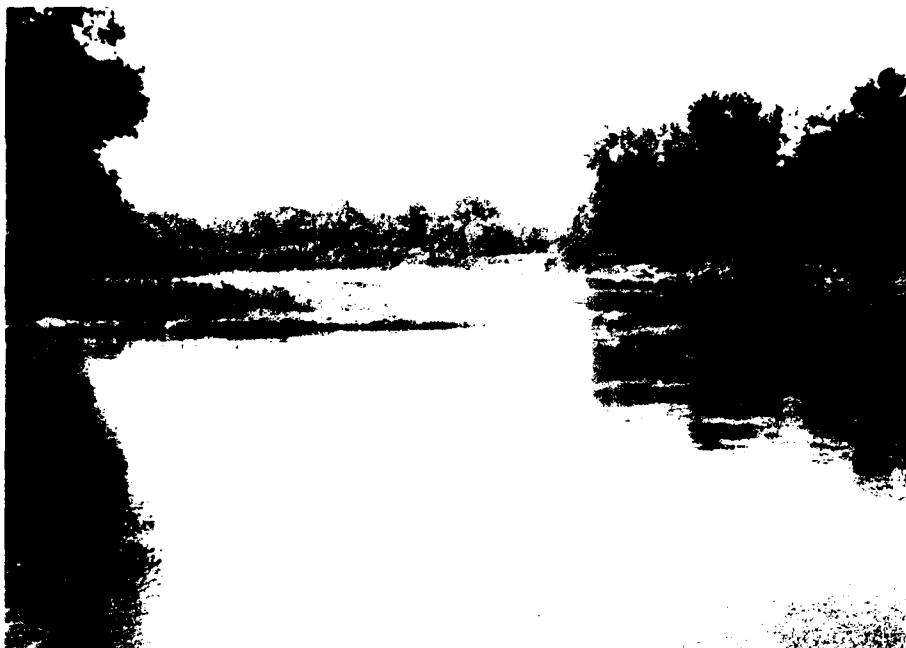
Pilot Channel 1, White River, Levee Unit 8 at Edwardsport, Ind. Downstream view of lower end of pilot channel at confluence with natural channel of White River (in background) (June 1978)

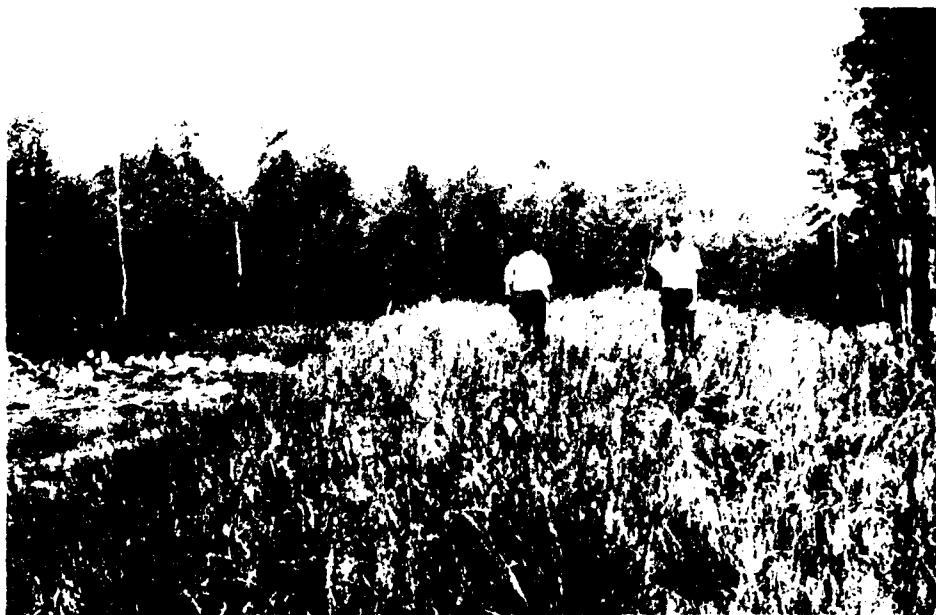
Pilot Channel 1, White River at Levee Unit 8, Edwardsport, Ind. Planted grass has been well established on the excavated pilot channel materials placed on both banks (20 June 1978)

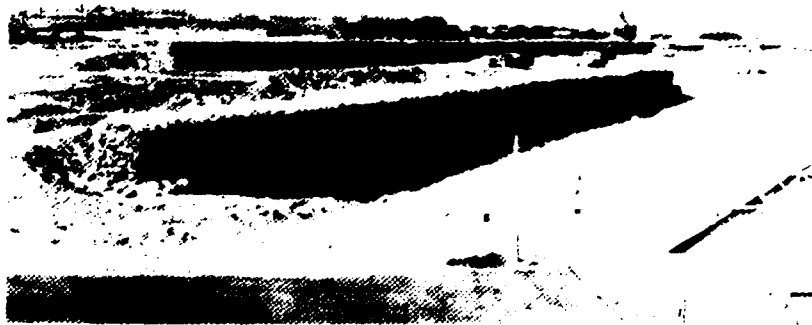
7. Acceptance of Structure and Blending with Natural Surroundings. The mid-floodway gabion barriers blend well with the natural surroundings. This may be observed in photos 1 through 5 on Items 45-6 and 7. The barriers have local acceptance.

Photo 1 Mid-Floodway Gabion Barrier Looking Downstream
from Garnet St. Bridge as Constructed

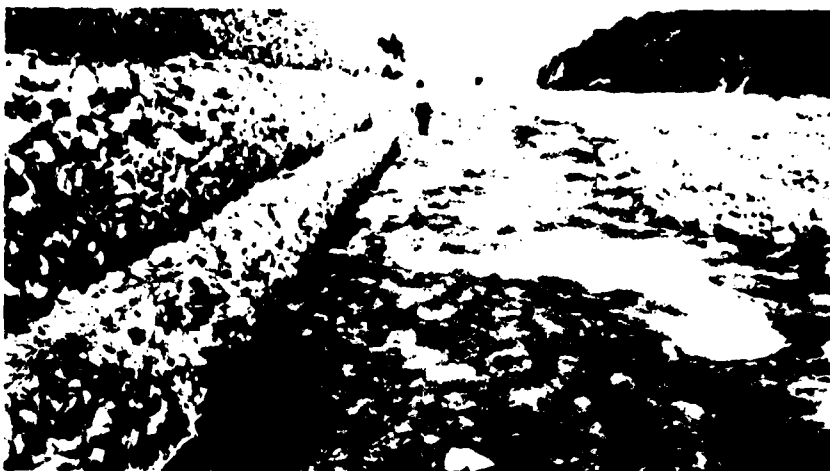
Runoff from the storms of 8-14 February 1978 and 3-6 March 1978 caused some damage to a 200 ft portion of the most upstream gabion barrier shown

in photo 3 on Item 45-7. As shown in photos 4 and 5 on Item 45-7 water impinged upon the gabion barrier. The only damage to the barrier was the erosion of the top wires of the mattress. To maintain the integrity of this portion of the gabion barrier the modification shown in figure 5 on Item 45-5 was constructed in September 1978. There was no damage to the gabion barriers downstream of Garnet Street.

Photo 3 Gabion Barrier Upstream of Garnet St. Looking Upstream from Streambed (July 1978)

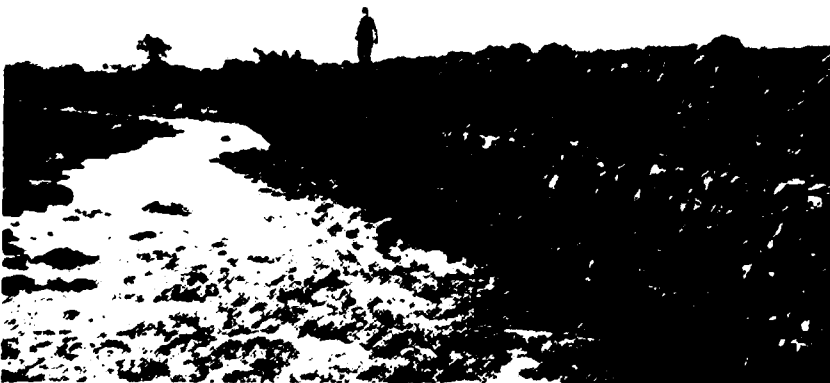
Photo 4 Gabion Barrier Upstream of Garnet St. Looking Upstream at Flow Adjacent to Barrier (July 1978)

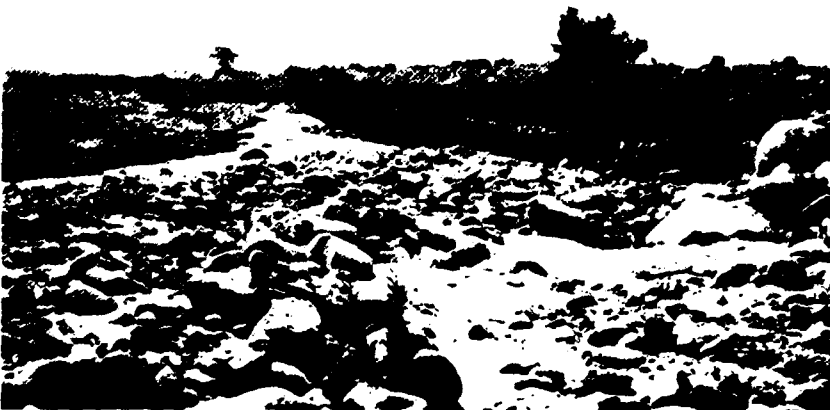
Photo 5 Gabion Barrier Upstream of Garnet St. Looking Downstream at Flow Adjacent to Barrier (July 1978)

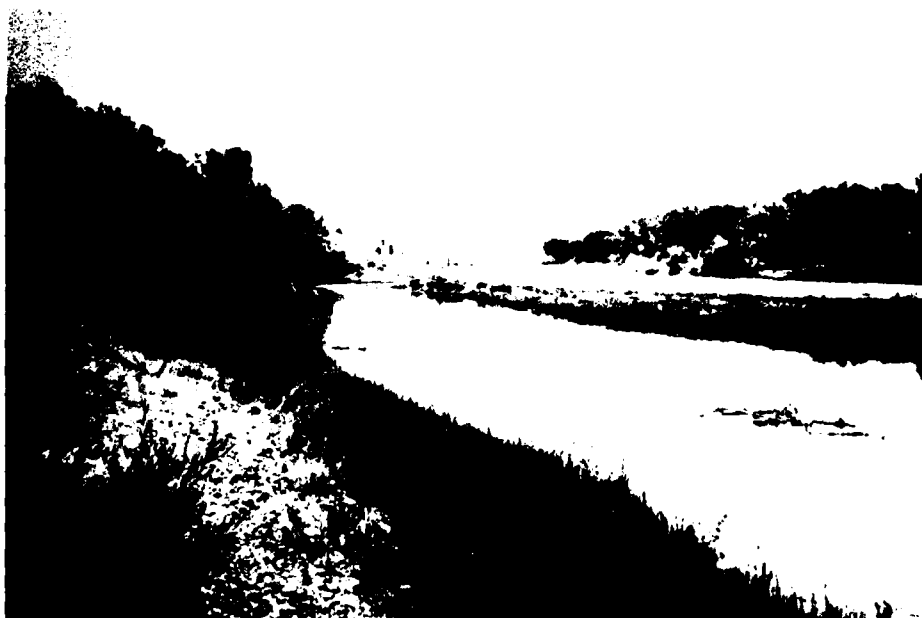
3. Six new jacks were required in 1969 as a repair measure. Beginning in 1972 a gravel bar began to build up in front of the project which has served to direct the flow away from the Kellner Jack Field (Item 46-5). The last inspection, conducted in November 1976, indicated that the project has been effective in preventing further bank erosion and has encouraged sediment deposition and general restoration of the eroded bank.

A gravel bar that began forming in 1972 has directed the streamflow away from the project

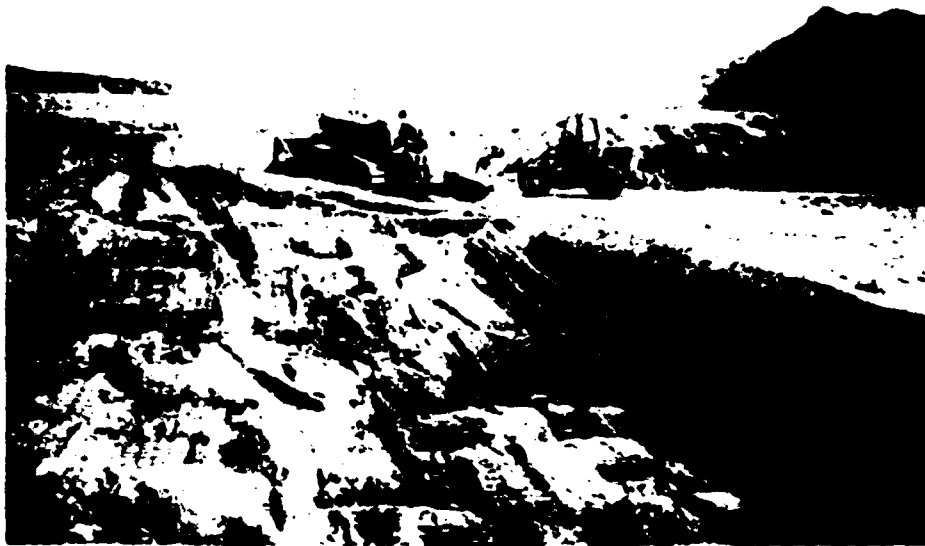
7. Before repairs of the 1975 flood damage, another 15,000-25,000 cu yd of levee erosion occurred in the September 1976 flood. In October 1976 and April 1977 the south levee was repaired. The now completed work includes: (a) placement of compacted fill secured from the channel bed in the eroded areas of the levee; (b) placement of rock-fill protection in selected portions of the restored levee; (c) completion of the gabion revetment installation on the west end of the levee; (d) installation of eight training dikes between the existing training dikes and the gabion revetment installation. A project map for this work is shown in Item 47-2. Federal and local participation costs were \$38,000 and \$22,000, respectively. Land use reevaluation of the area behind the north levee indicated that there was nothing of value to protect; therefore, no efforts were made to protect this levee, thus allowing the creek width to expand and reduce flow concentrations along the south levee.

Fill material for eroded levee areas was secured
from the channel bed

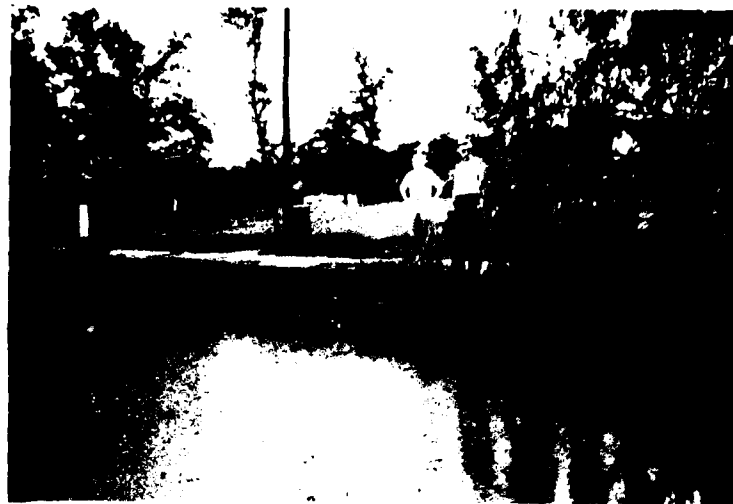
ITEM 49-5

Timber sheet-pile wall boat dock eight years after construction

Recommendations Replace cap boards and fill scallops with stone.

Map No. 49. Repairs could be done at relatively small expense. Continuous minor repair work will maintain the usefulness of this shore protection for the public good. On new projects, scallops at ends of the wall should be controlled by use of an adequate riprap blanket at turnbacks. Use cypress timber.

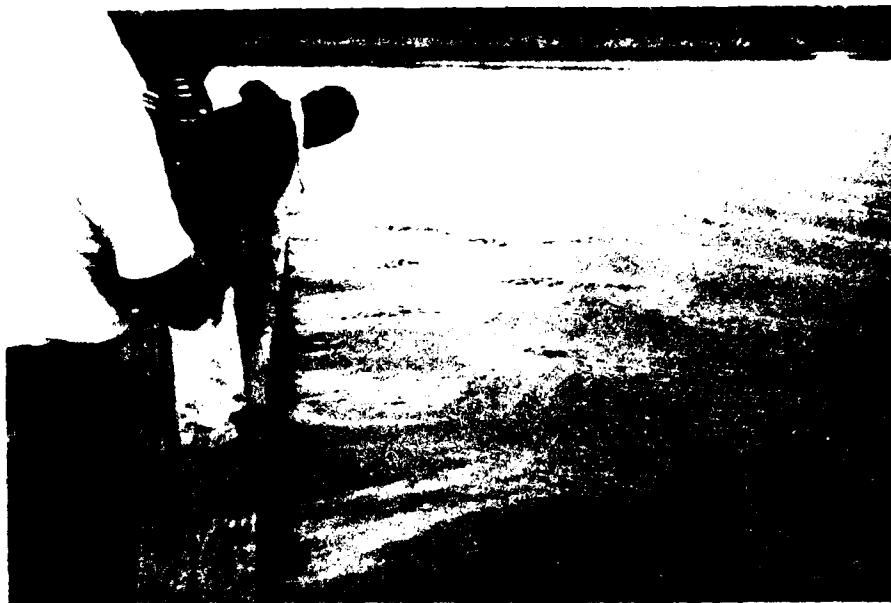
ITEM 49-7

Wall V
Loss of some embankment fill behind wooden wall
